# APPENDIX B

## Community Ignitability Analysis and Recommendations

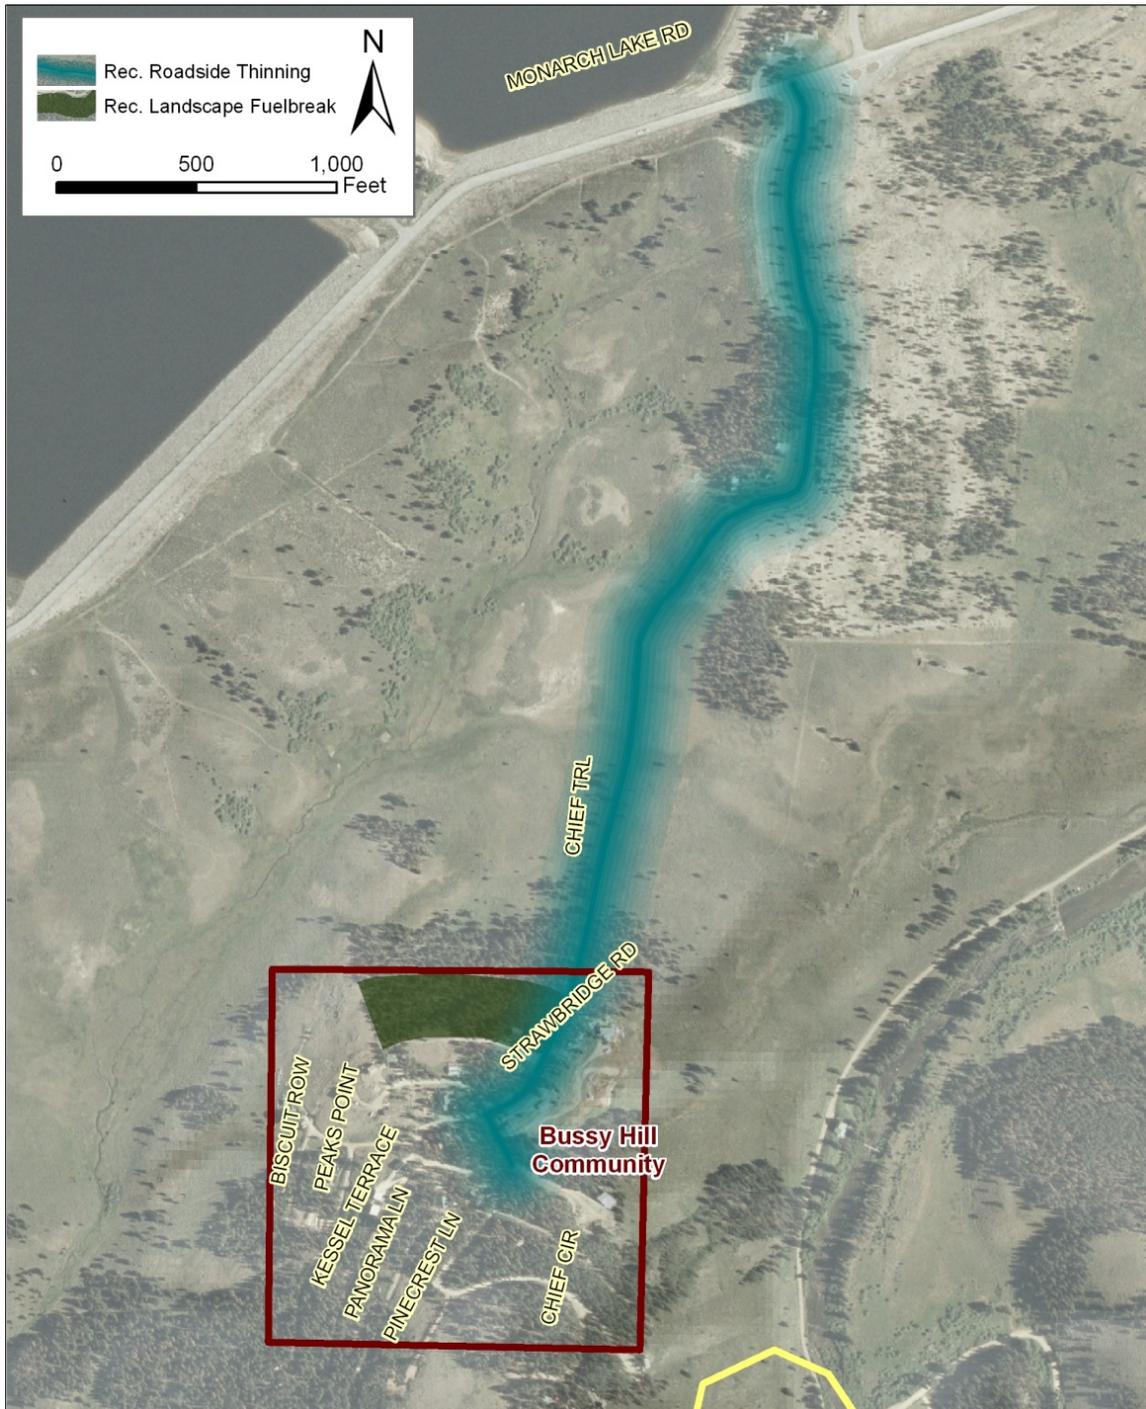
Figure 2. Bussy Hills Fuels Treatment Projects

This community has one of the highest hazard ratings in the study area. Access is difficult because of the steep dirt roads, which are mostly 4wd accessible only. There are only 25-30 homes in this community; however there is only one way in/out. There is no defensible space surrounding any of the houses. All homes have propane tanks, which need to be mitigated properly and maintained. The southern part of the community is at greater risk due to the increased tree density and canopy cover. Above ground power lines pose a threat, especially as the beetle attacked trees start to fall. There is no on-site water supply for this community.

- A landscape fuelbreak is recommended for this community on the northwest side (see **Figure 2**). This fuelbreak project serves to decrease fuel continuity and as a result, prevent fire spread into the Bussy Hill community. It also protects access and egress along Biscuit Row, should a fire occur. Placing the fuelbreak at the base of the hill will provide the most benefit for the entire community.

- Roadside thinning and mowing is recommended along the Chief Trail Road (see **Figure 2**). Living trees should be limbed and trimmed along the Chief Trail Road. Standing dead trees that could fall and cut-off road access should be removed, and open areas should be mowed. Roadside mowing should begin from the intersection of Chief Trail Road and Billie Lane and continue north to the lake.

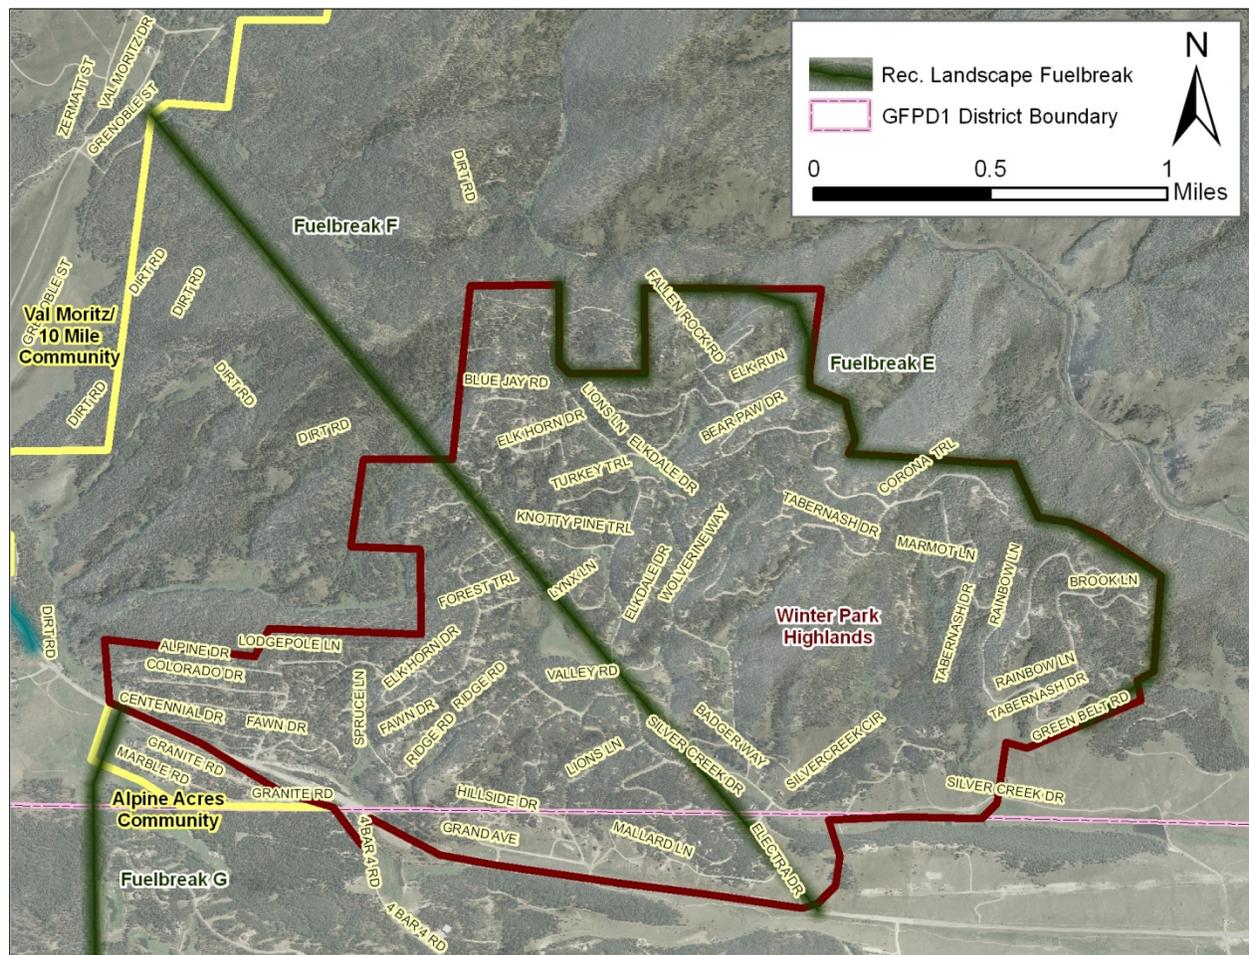
Figure 3. Winter Park Highlands Fuels Reduction Projects

Fuels are generally heavy loads of mixed conifer with substantial insect mortality. Stands have plentiful ladder fuels and significant surface loads of dead and down materials. There is a railroad line that runs along the bottom of steep slopes below this community which is an additional ignition hazard. The topography in this community is steep and complicated by ravines and drainages. Active fire behavior can be expected under both moderate and especially under extreme weather conditions. Long flame lengths, high rates of spread and active crown fire are possible.

- a) Survey Greenbelt D to determine actual area to be cleared.
- b) 10 acres of logging clear cut (approximately 150' wide) below the ridge in Greenbelt D.
- c) Re-opened old forest service road and added 300 yards of road clearance to allow access for fire protection and emergency equipment.
- d) Training for property inspectors from Colorado State Forest Service, Granby Fire District, community education for WPHOA, and distribution of Upper Fraser Valley CWPP.
- e) 44 homeowners did fuel reduction & fire mitigation on approximately 90 acres around their homes & property in Winter Park Highlands.
- f) Inspection of above properties by trained WPHOA team.

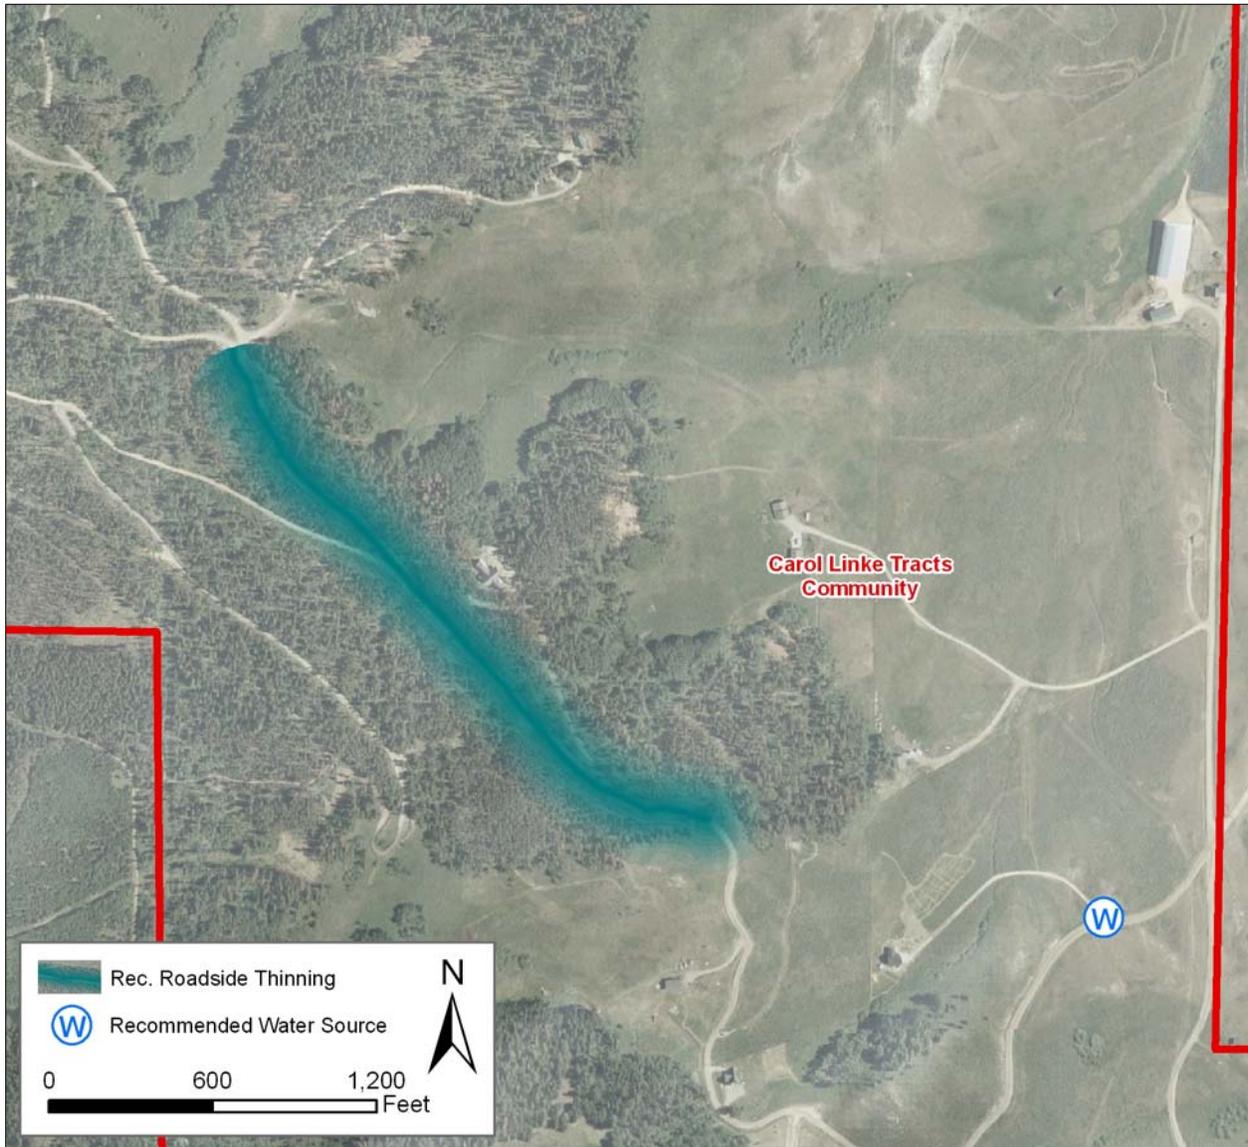
Figure 4. Carol Linke Tracts Fuels Reduction Projects

Fuels in this community are grass and brush fuels, with some timber – mostly dead Lodgepole. There are slash piles that add to the surface fuel loading from small cutting projects that have been going on. Under moderate conditions, surface fire spreading through the brush is most likely. Small pockets of surface fuels located next to lodgepole pines may cause individual torching. Extreme weather conditions are of concern due to the quick rates of spread through the brush and hence long flame lengths, which may likely cause active crown fire, especially through the stands that have beetle kill and still have needles on the trees.

- Dead trees along road sides create potentially dangerous situations, especially when there are high winds. Removal of all dead trees along access routes is recommended for the safety of those traveling these routes. Much of this should be focused along Thompson Road (see **Figure 4**).

- The addition of a 30,000 gallon cistern for water supply is recommended since the community currently has to water. A recommended location for this cistern can be seen in **Figure 4**.

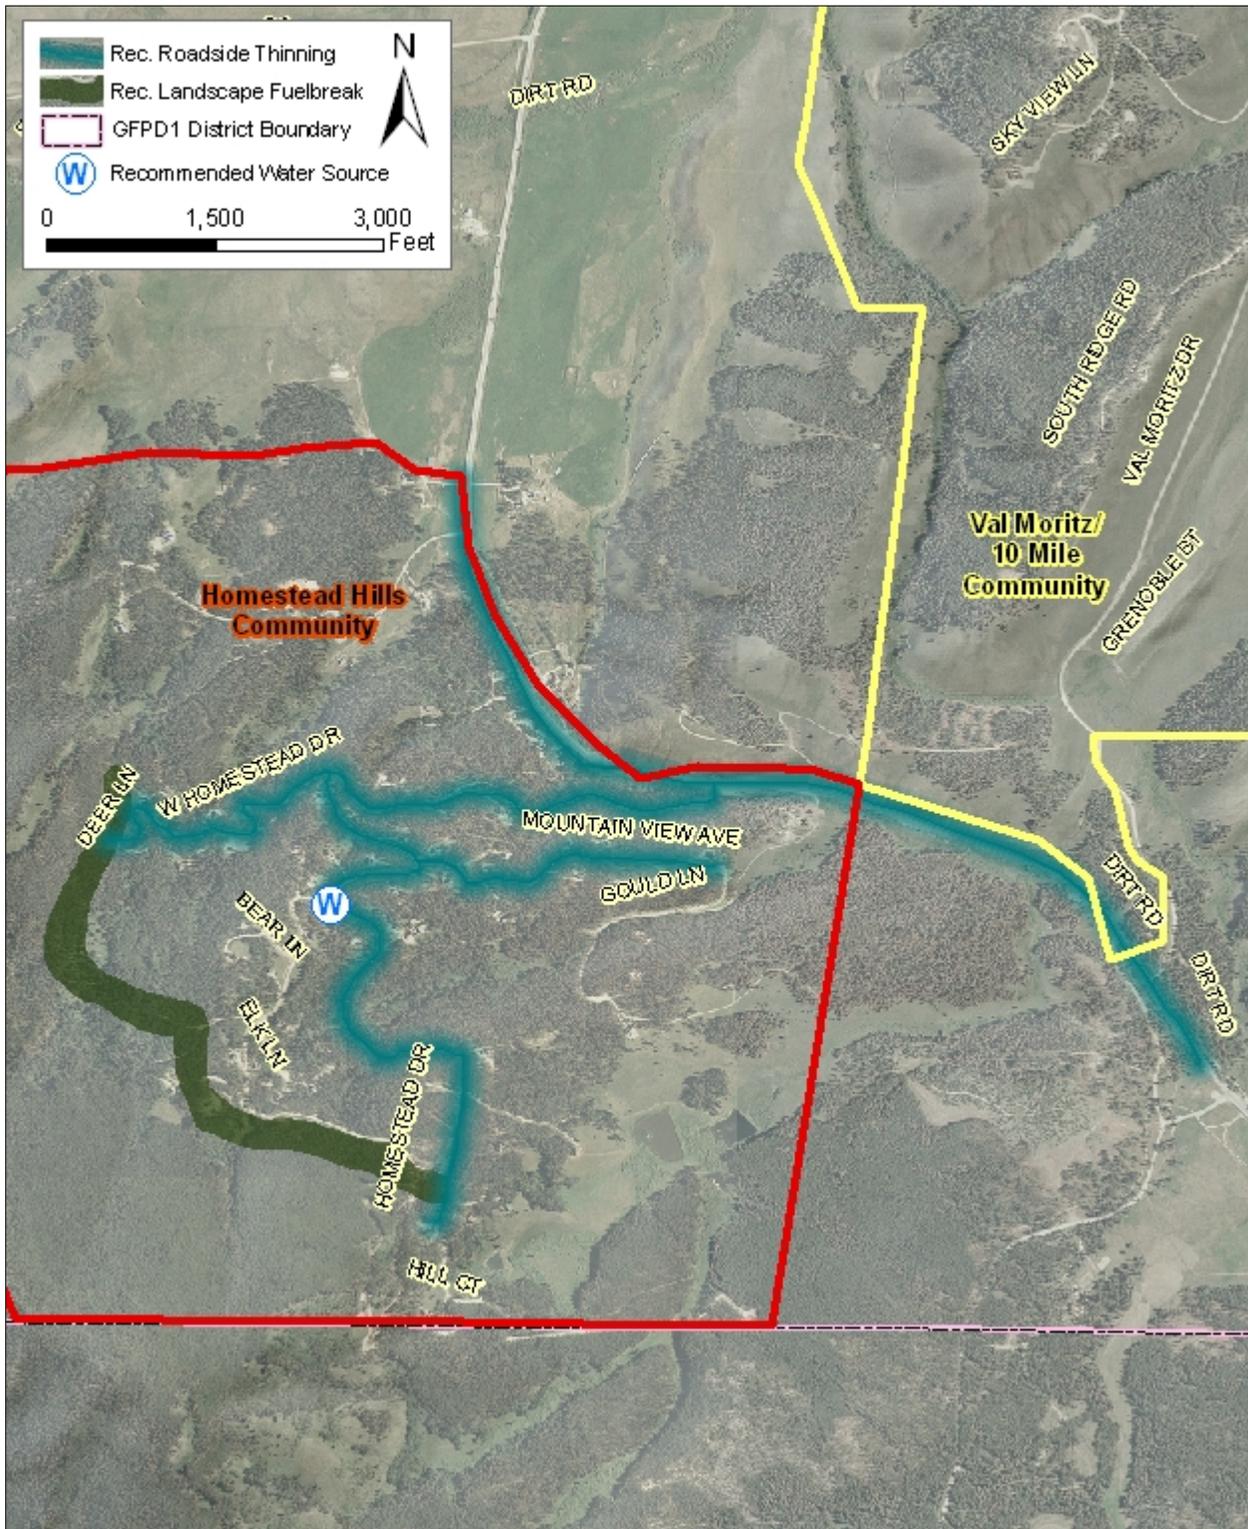
Figure 5. Homestead Hills Fuels Reduction Projects

Lodgepole pines comprise the majority of the fuel type in the community, and most of these trees have been attacked by the mountain pine beetle, especially on the west side of the community where there is a higher component of forested areas on the hillside. There is less mortality in the lower areas of the community. Under Moderate fire conditions, a surface fire would be most probable given the low surface fuel loading and moderate levels of ladder fuels. Slower rates of spread and lower flame lengths should also be expected. However, the even-aged and dense nature of these stands, combined with the red needle phase of the trees could produce active crown fire under extreme conditions.

- A landscape scale fuel break is recommended for this community along Nine Mile Mountain on the west side of the community. This fuelbreak should tie into the open area near Deer Lane and continue south to the hairpin curve in Homestead Drive. The fuelbreak should be approximately 600-800' wide, following along the uphill side of the road. This project is intended to decrease flame length intensity that may impinge upon road access during a fire. The project occurs along the roadside for operability, not as a roadside thinning treatment. It is possible that due to the topography, fire coming from the southwest of the road could have extreme rates of spread, long flame lengths, and high fire line intensity. Thinning and removing dead fuels, as well as mowing light flashy fuels will reduce ladder fuels and interrupt the crown continuity. It will serve to protect the egress route for residents in this community, as well as to provide a possible control line for firefighting resources.

- Roadside thinning is recommended along most of the roads within the community (see **Figure 5** on page B18). The most important need for roadside thinning is along HW 40, which comprises the northwest boundary for the community. Mowing, thinning, and removing dead trees along roads will protect ingress and egress routes for individuals and fire apparatus.

- It is recommended that a dry hydrant be installed on the Fox property, seen in **Figure 5** on page B18. Access should be developed with fire apparatus in mind.

- A 30,000 gallon storage cistern is recommended (see **Figure 5** on page B18). Additional water storage is useful, especially in combination with a dry hydrant. Work with the fire department to determine a beneficial location.

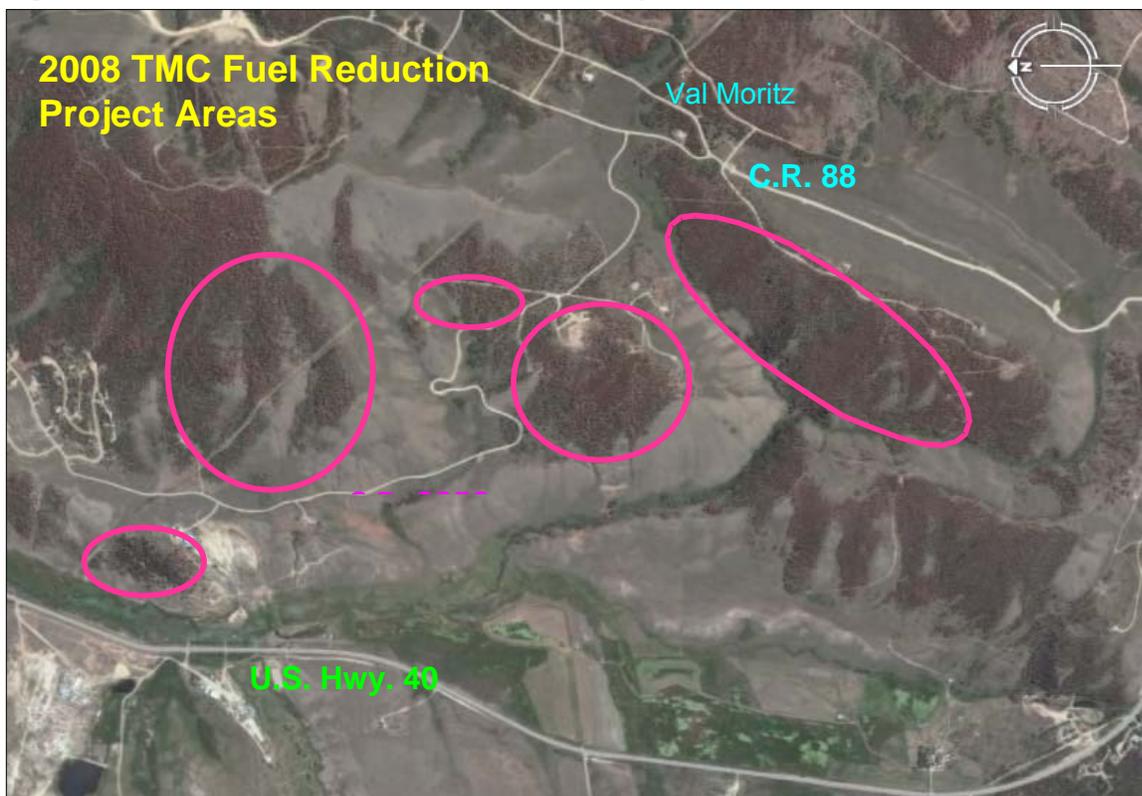
Figure 12. Val Moritz /10 Mile Fuels Reduction Projects<sup>2</sup>

<sup>2</sup> This graphic was taken from the 10 Mile Community CWPP. It identifies treatment areas of beetle killed lodgepole pine.
