# APPENDIX B

## Community Ignitability Analysis and Recommendations

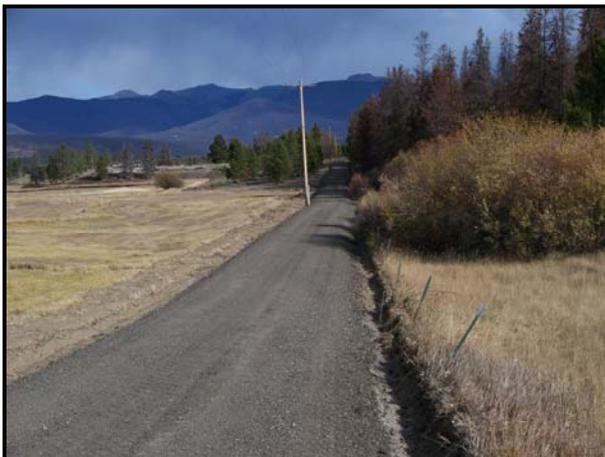
In 1982, the District completed construction of a regional waste water collection and treatment facility. The facility contains a minimum of 91,000 gallons of usable water for fire suppression. There is a gravity-fed 5" hydrant connection on the B side of the building. The access road is very narrow, and as a result does not allow safe and effective access for fire apparatus to this valuable water source. This water supply should be considered an alternative for surrounding communities.

- Improving the access road width to accommodate fire apparatus is recommended.

- Posting a water supply sign at the intersection of HW 34 and the entrance to the sanitation plant as well as on the sanitation plant sign is recommended.
